# Technical Service Bulletin

## 96 Garage door opener remote with 315MHz will not program to vehicle HomeLink

96 21 71 2051239/2 July 12, 2021. Supersedes Technical Service Bulletin Group 96 number 18-26 dated May 7, 2018 for reasons listed below.

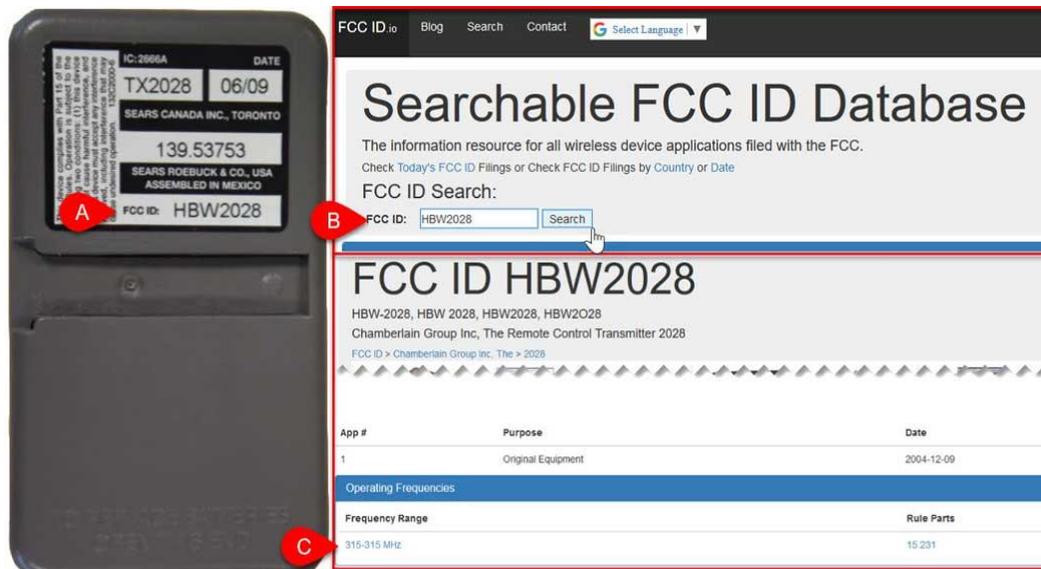
**Figure 1.** Checking the operating frequency.

Under certain circumstances, the radio signal of the customer's remote control may not be adapted to the vehicle.

1. Check the operating frequency of the customer's remote control:
  - Locate the FCC ID number of the customer's remote control (Figure 1, A).
  - Search this ID at <https://fccid.io/> (Figure 1, B).
  - Locate the Frequency Range of the remote control (Figure 1, C).

2. If the operating frequency of the customer's remote control is 315MHz (+/- 10MHz), continue with this TSB. If not, then continue diagnosis outside of this TSB.
3. Adapt the customer's remote control to the vehicle with the side assist modules disabled:
  - Remove Fuse -SF4- (5A) (Figure 2) 30 power for the lane change assistance control module, J769 (address word 003C) and the lane change assistance control module 2, J770 (address word 00CF).
